# Home Energy Evaluation Report for House One

House One  
Canterbury Woods Community  
Annandale, VA

**Inspection Date:** June 9, 2010

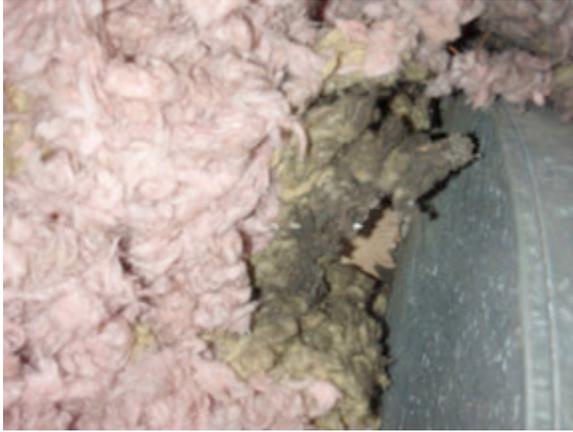
Air leakage around duct trunk  
(dirty insulation)

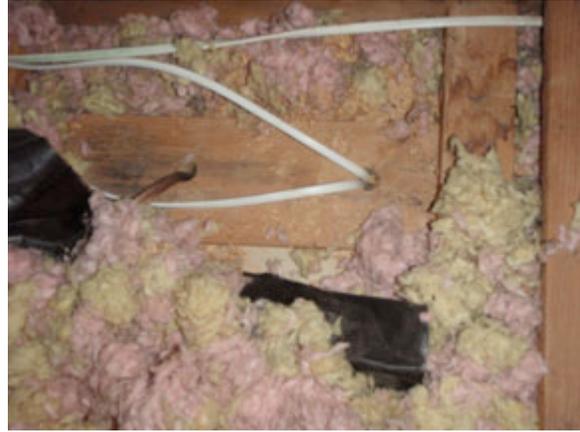
Unsealed top plates & wire holes,  
thin/no insulation

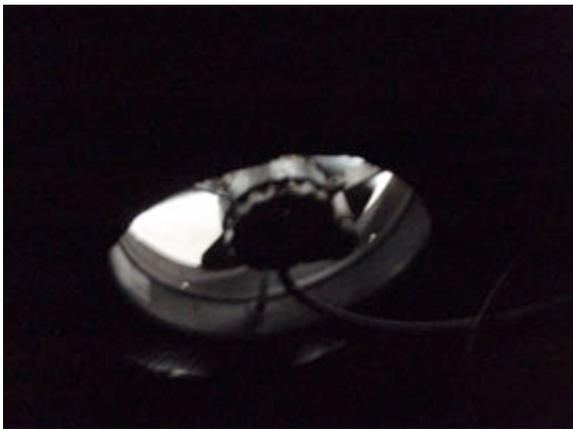
Fan draws conditioned air from  
living space

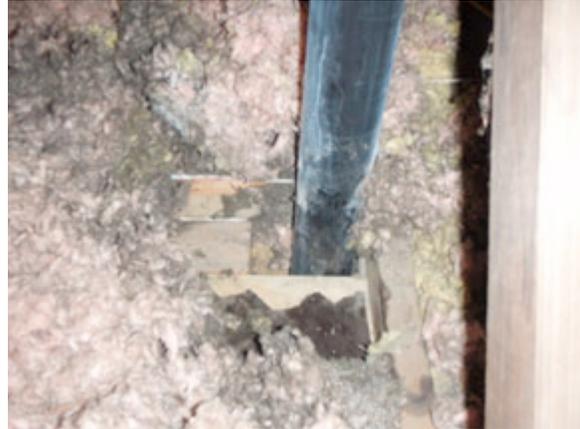
Open flue chase – air leakage  
(dirty insulation)

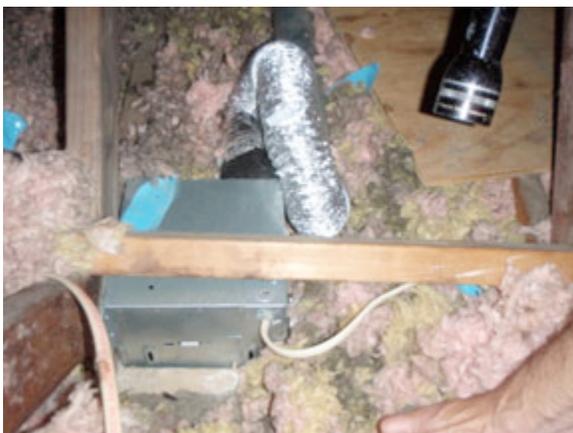
Gaps around bathroom exhaust vent  
loop in exhaust duct

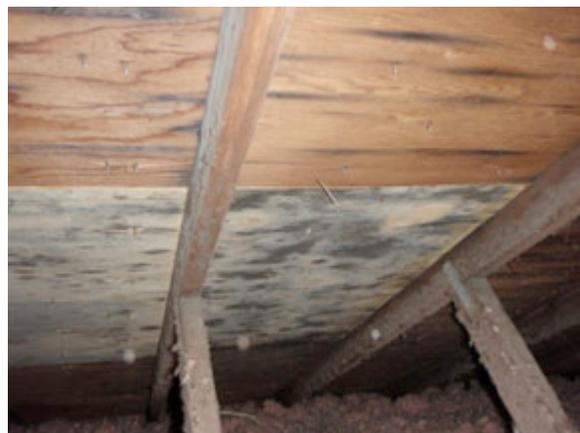
Repaired plywood w/ signs of new mold  
rusting nails on roof deck – there is an  
abundance of moisture located over the  
bathroom

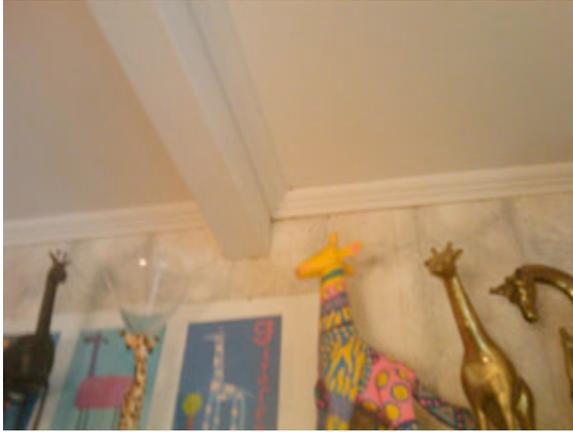
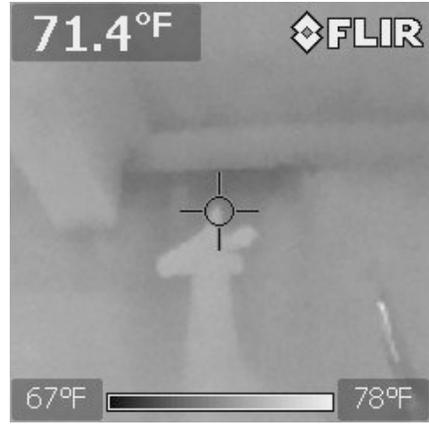
Air leaking at top plate of wall

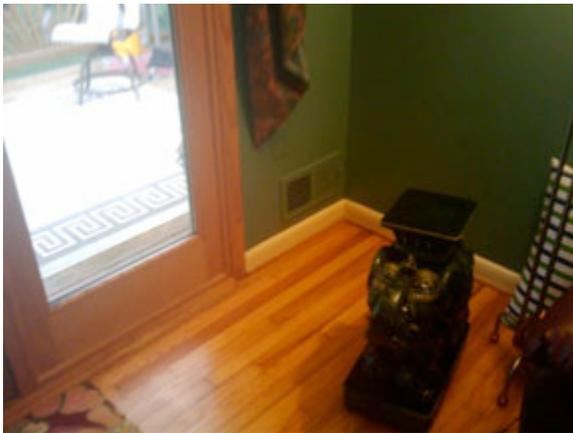
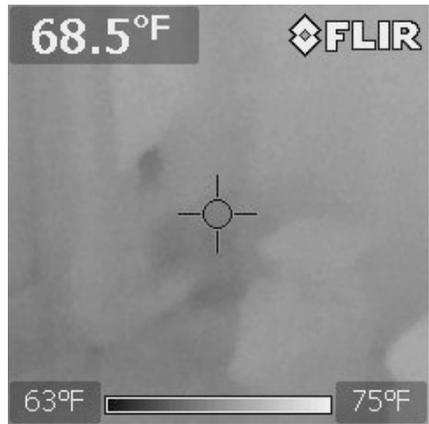
Air leaking through electrical outlet and ducts

- 1) Install air tight recessed light trims or install cover over housings in attic.
- 2) Seal electrical boxes located in the exterior envelope.
- 3) Seal ducts at perimeter of the house where accessible and reachable from the inside.

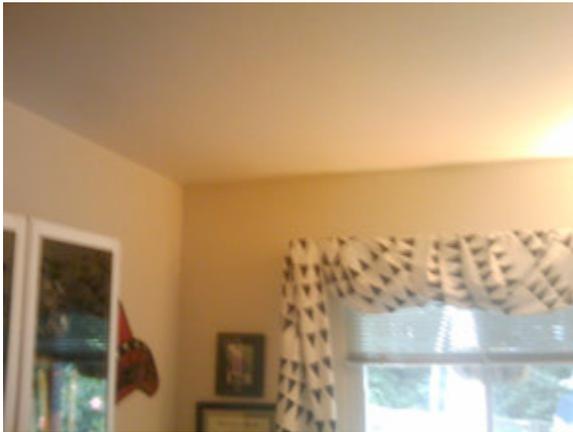
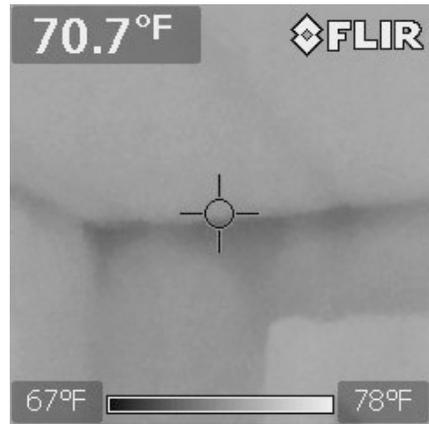
Air leaking through top plates

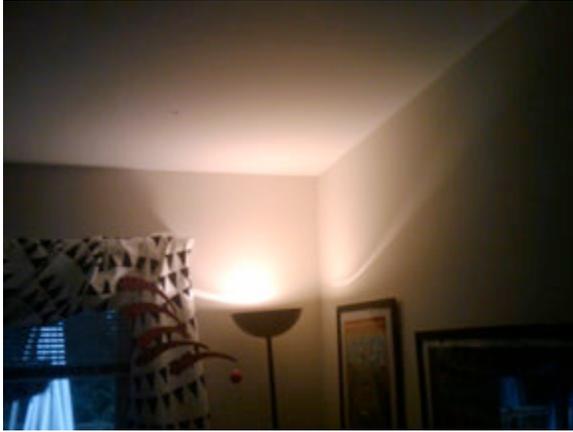
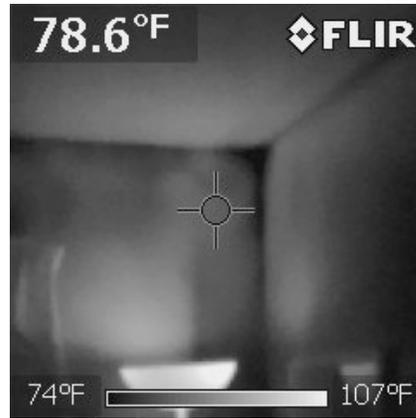
Unsealed top plates

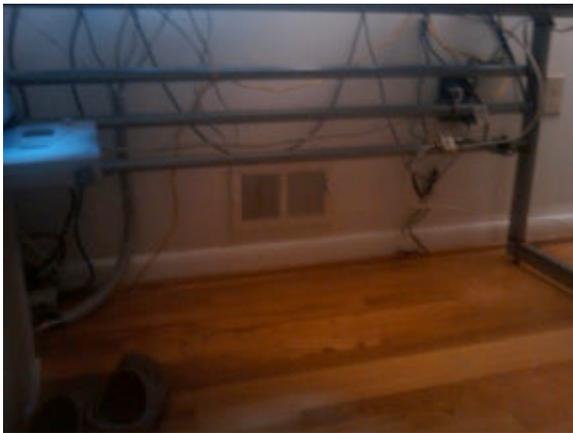
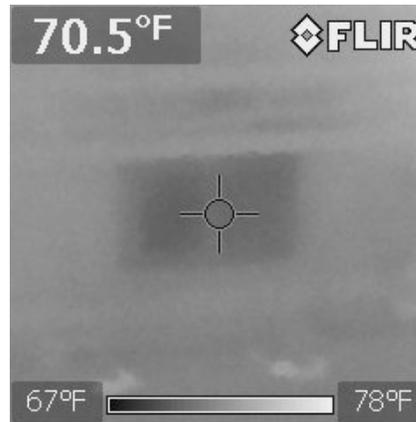
Air leaking through duct work

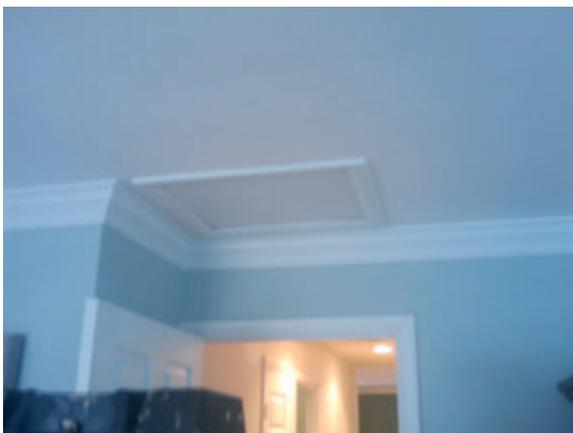
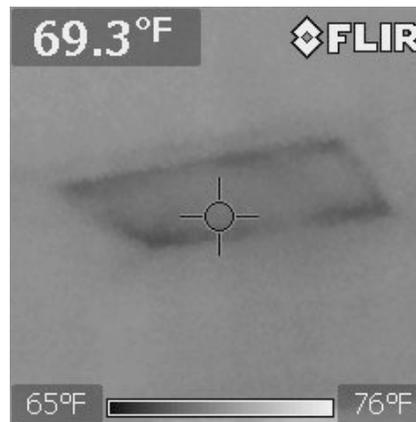
Air leaking through attic hatch

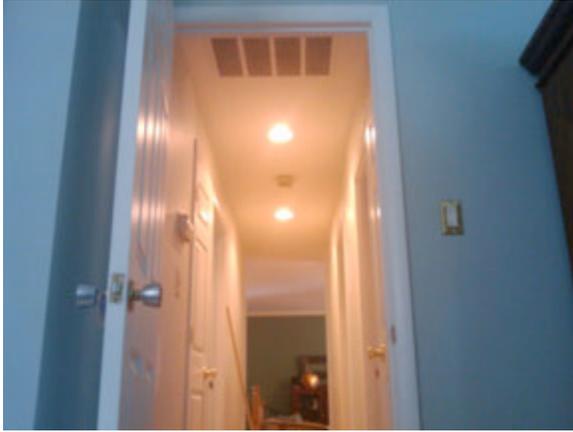
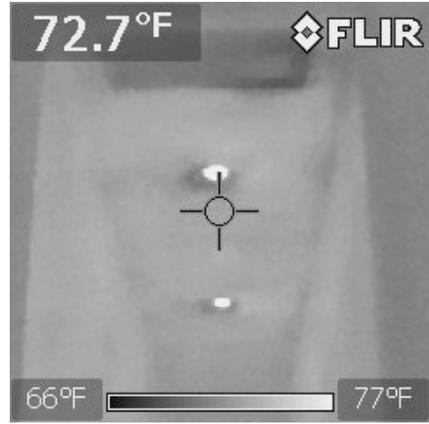
Air leakage through recessed lights and return duct

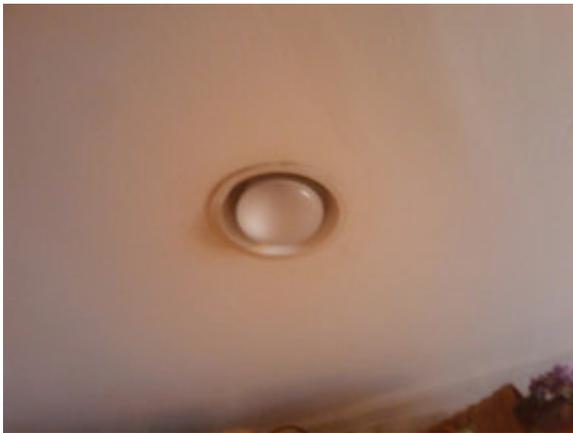
Opening to attic

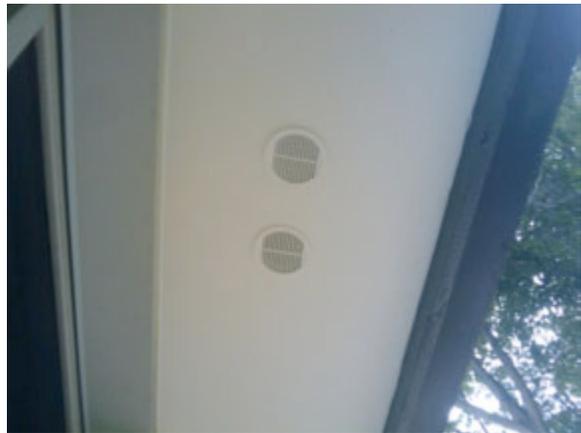
Inadequate bath fan outlets

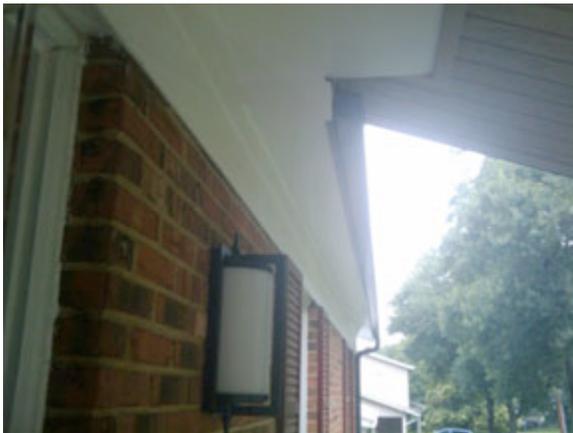
No ventilation inlets at soffit

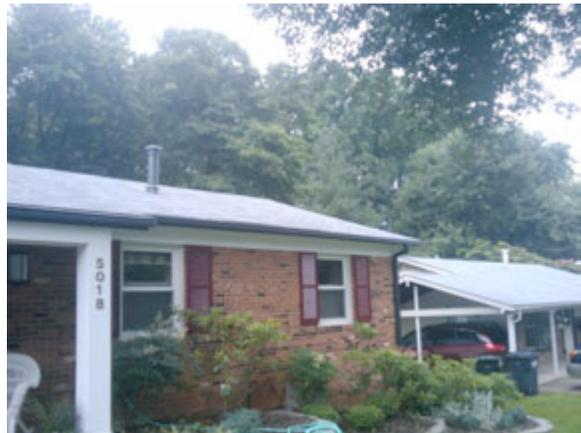
No ridge vent on roof

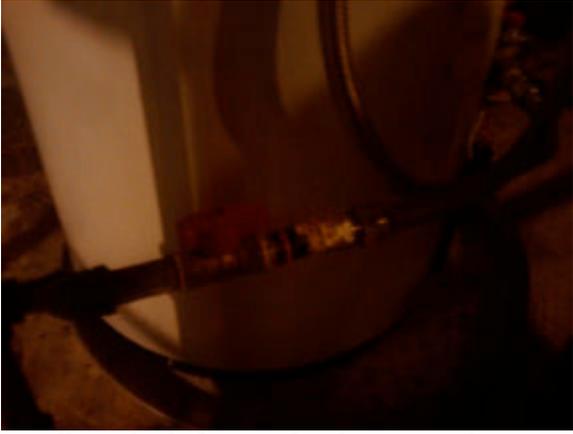
A gas fired hot water heater and furnace are located in a utility room in the basement. The hot water heater and furnace passed carbon monoxide spillage and drafting tests. One small gas leak

was detected at the hot water heater. ***This should be serviced by a licensed gas fitter/plumber before any home envelope sealing is undertaken.***

Small gas leak detected at hot water heater

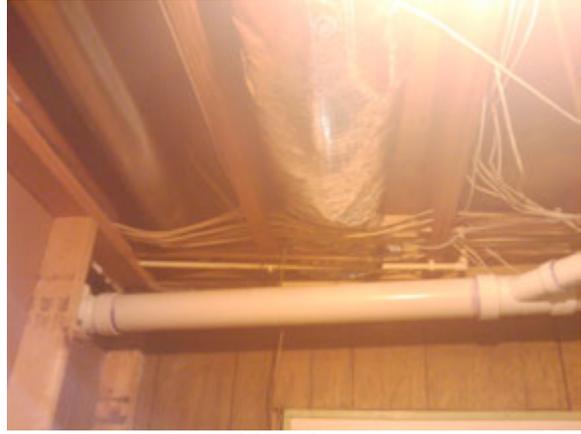
Unsealed band joists

- 1) Spray foam band joist where accessible.
- 2) Replace older windows with Energy Star qualified windows.
